# Manhole Inspection Summary

Manhole # S37CC1033MH

Insp Date: **12/8/06 11:25 AM**

**Location** Address: **3614 GREENMOUNT AVE**

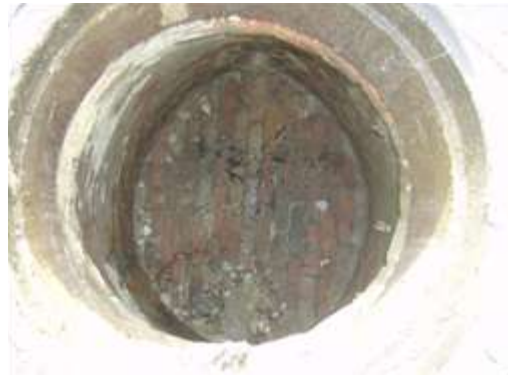
Top View

Channel debris. Corroded and missing steps.

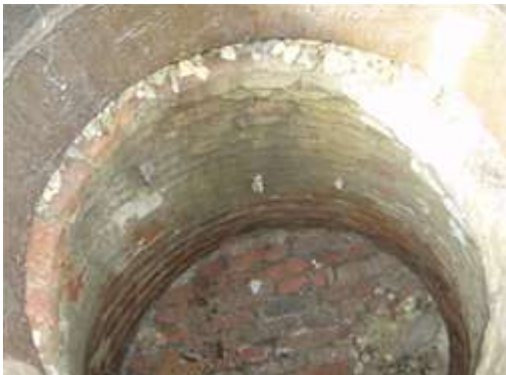
Defect

Frame leaks. Adjustment deterioration and infiltration.

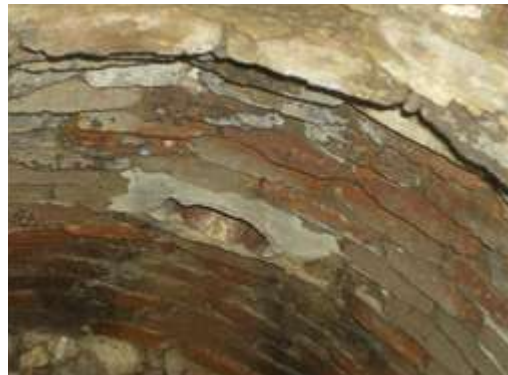
Defect

Adjustment, Corbel and Barrel infiltration.

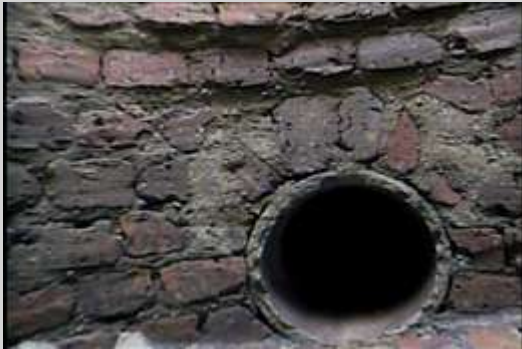
### 8 in. Circular Gravity Sewer Pipe Out @ 12 O'Clock

Pipe Material: **Clay** ☐ Pipe Lined

Invert Depth: **5.40** (ft.) Flow Characteristics: **None**

Infiltration: **None** Pipe Seal Cond: **Sound**

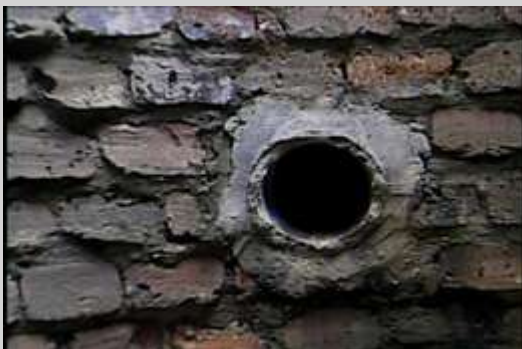
### 4 in. Circular Gravity Sewer Pipe In @ 7 O'Clock

Pipe Material: **Clay** ☐ Pipe Lined

Invert Depth: **3.35** (ft.) Flow Characteristics: **Slow**

Infiltration: **None** Pipe Seal Cond: **Sound**
